# melett

## ① OVERSPEEDING

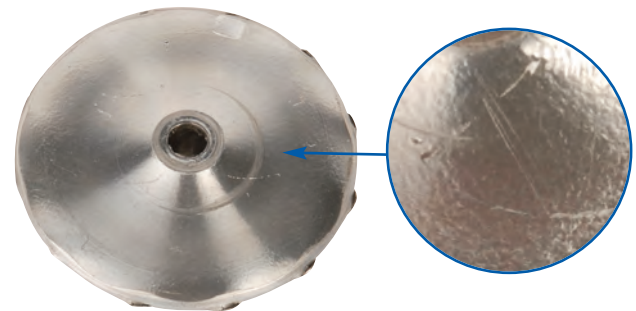
'Orange peel' effect on the back face of the compressor wheel is created by expansion and contraction. When the compressor wheel overspeeds it grows in size. This expansion causes cracks between the grain boundaries of the material, in mild cases this returns back to its original state (like elastic) but in most cases these cracks begin to grow and eventually part of the hub can break away.

The 'orange peel' effect on compressor wheels

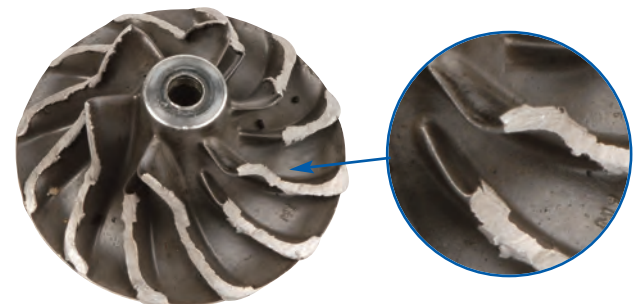
could have broken away from the bearings as a result of the overspeeding and imbalance caused by this. This imbalance can also cause compressor rub and turbine wheel rub in the housings, which in turn can lead to the shaft snapping and loss to part of the inducer blades.

Compressor wheel rub

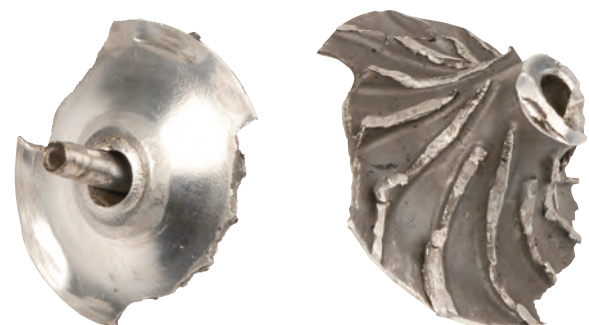
Complete component failure
